**WETLANDS DELINEATION & STREAM
ASSESSMENT REPORT**

**55 ACRES
N. ELM ST. & MO ROUTE CC
MARSHFIELD, MISSOURI**

Project Number: 235292

May 23, 2016

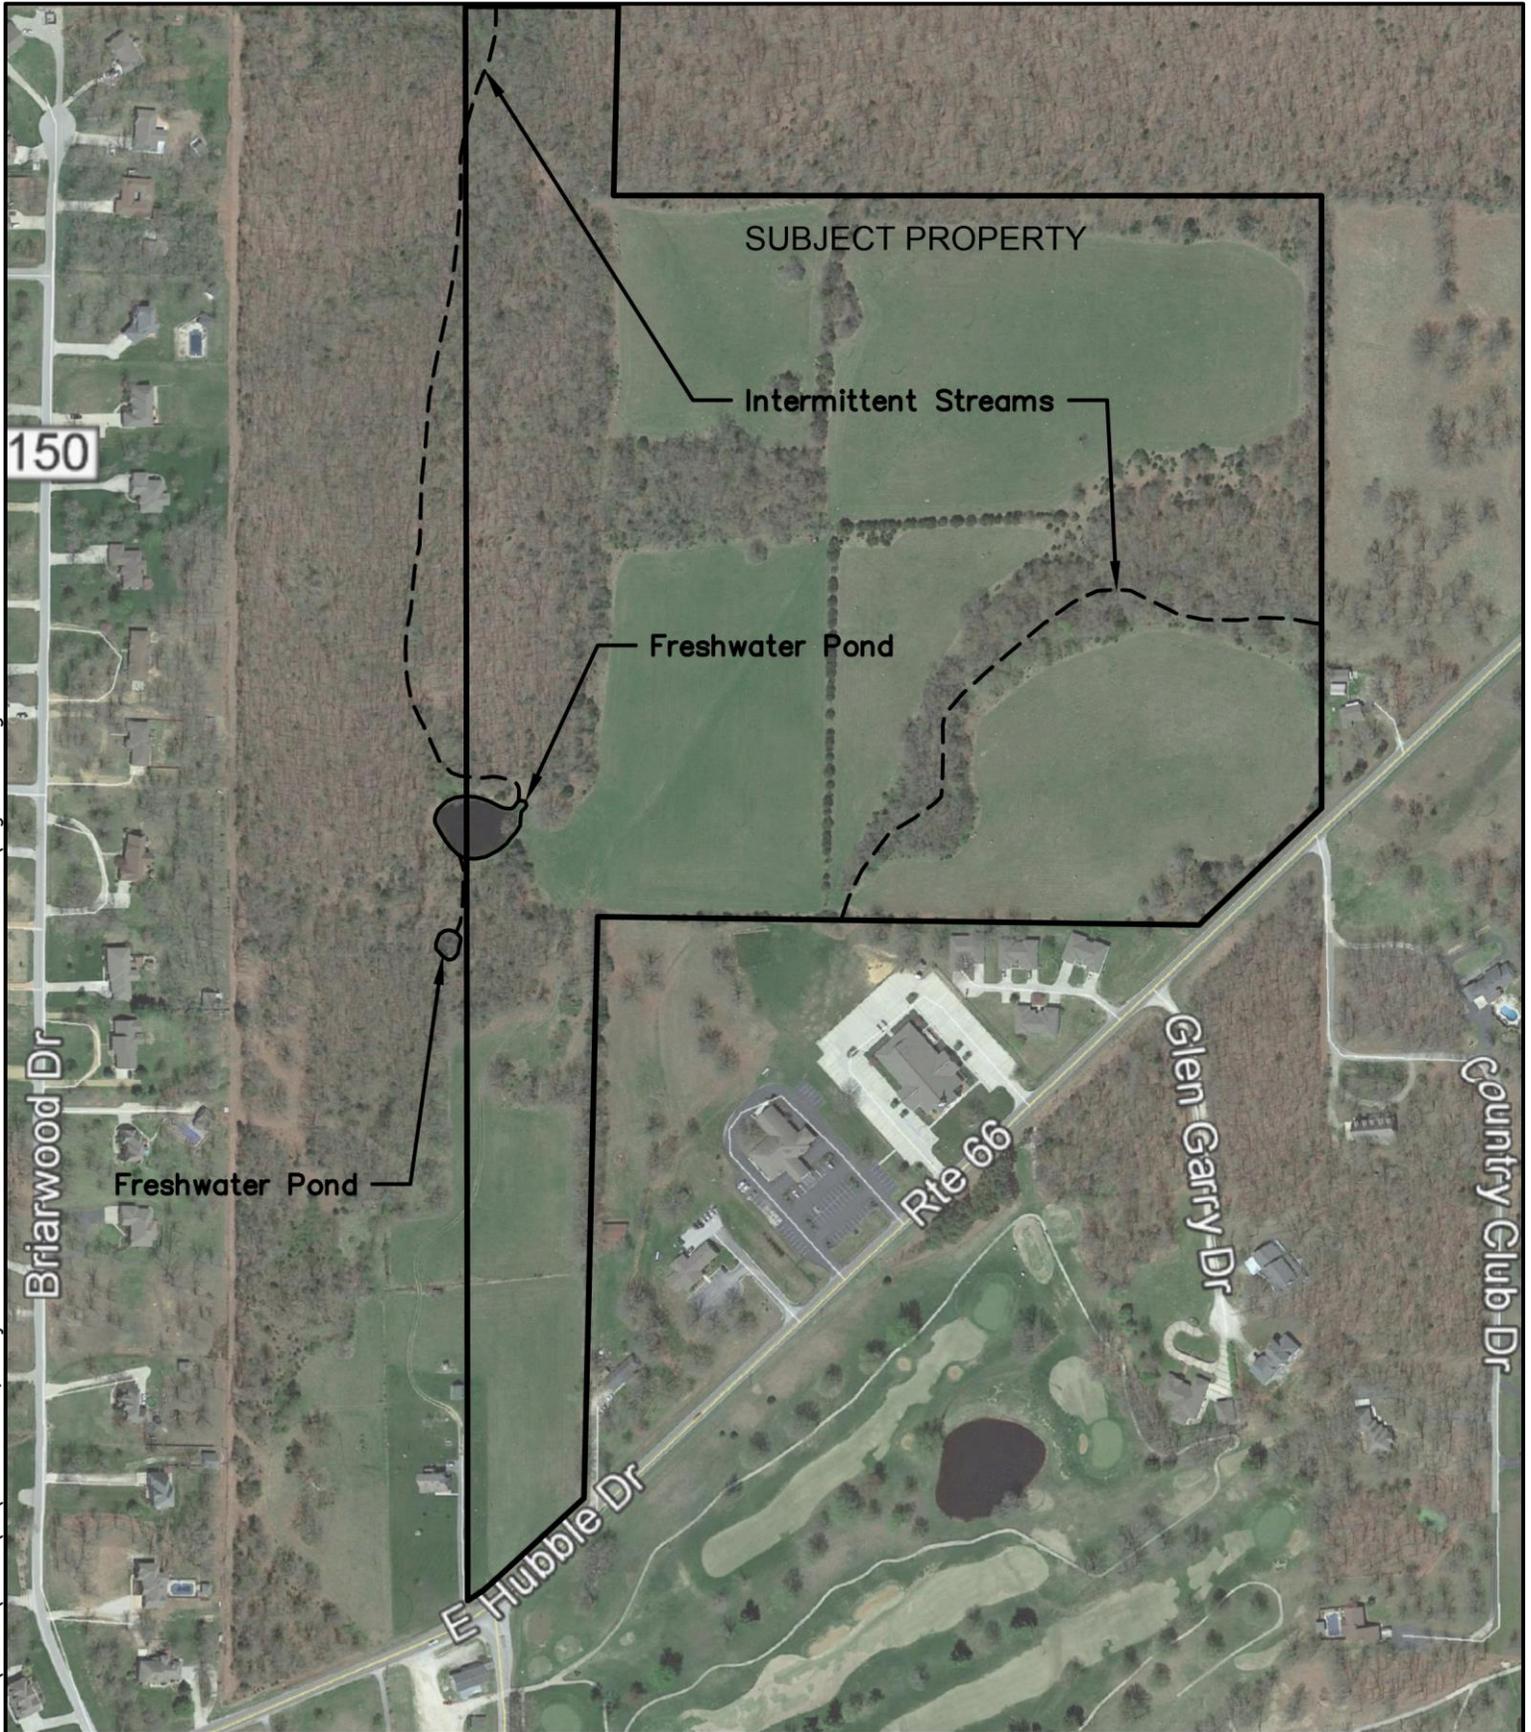
Wetland & Intermittent Stream Locations

The only wetlands observed on the subject property is the man-made freshwater pond located on the western boundary of the subject property. The wetlands flora *Typha* (cattail) was observed growing within and on the banks of the pond. See the figures in Appendix I for maps showing the location of the freshwater pond wetland and the output from the *Wetlands Mapper*. See Appendix III for photographs of the freshwater pond.

The intermittent streams that are depicted on the USGS topographic map were observed on the subject property. The western intermittent stream originates from the freshwater pond, flows onto the west adjacent property, and then flows back onto the subject property in the northwest corner before flowing off of the subject property to the north. The eastern intermittent stream originates on the southeast adjacent property and flows across the

southeast corner of the subject property. During the site reconnaissance the western intermittent stream was observed to be flowing steadily with depths of 0.5 to 1.0 feet and the eastern intermittent stream was dry. Neither of these streams are identified by the Missouri Department of Natural Resources as losing or gaining. Additionally, no springs are identified by the Missouri Department of Natural Resources as being on the subject property and were not observed during the site reconnaissance. See the figures in Appendix I for maps showing the location of the intermittent streams. See Appendix III for photographs of the west intermittent stream.

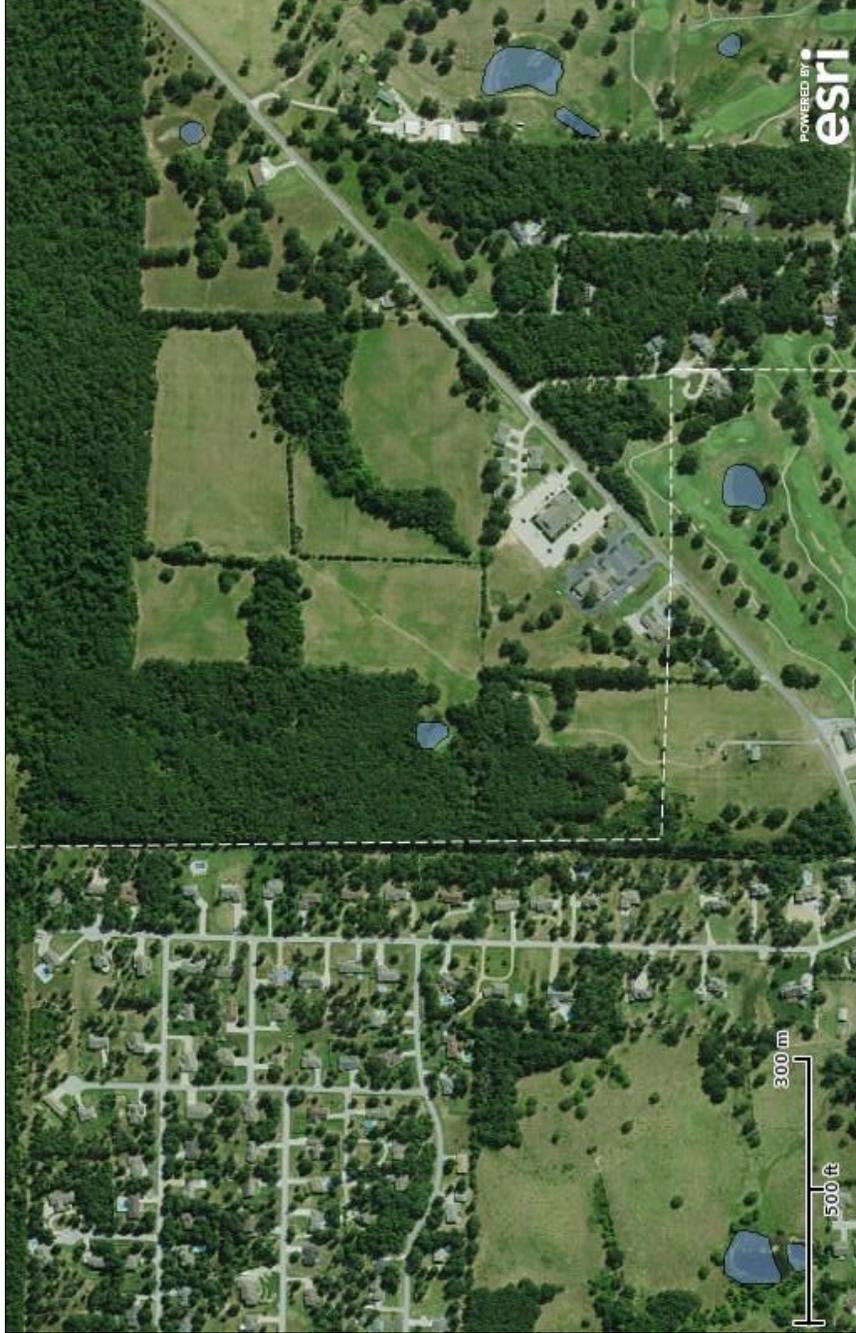
National Wetlands Inventory

The *Wetlands Mapper* identified one (1) wetlands feature, a freshwater pond, on the subject property. The topographic map shows two (2) intermittent streams crossing the subject property. These intermittent streams flow into the East Fork of the Niangua River. The *Web Soil Survey* gave no indication of wetlands or soil types that include hydric soils. See Appendix II for the output from the *Web Soil Survey*.

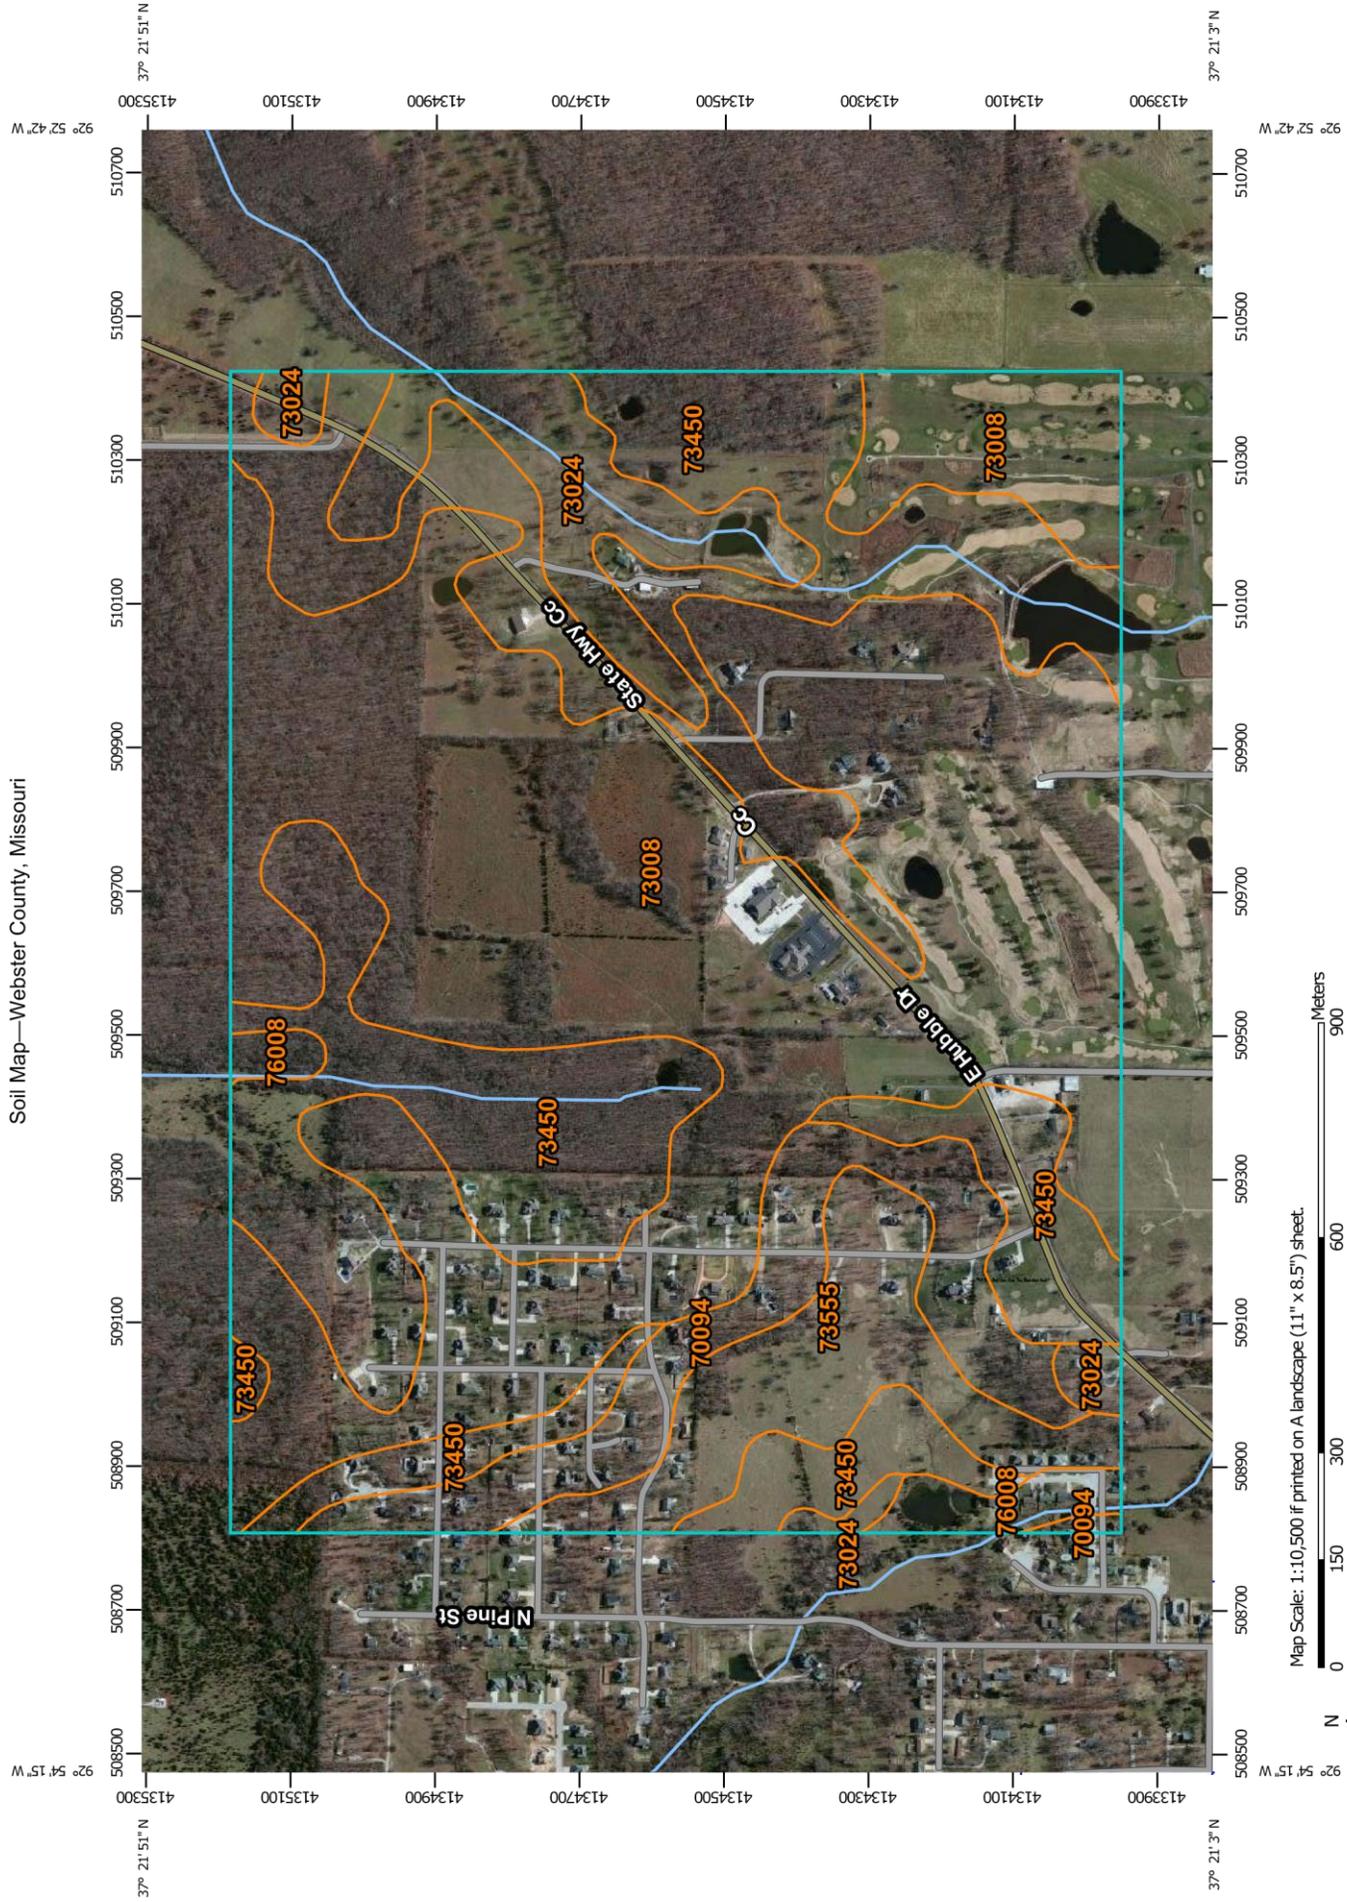
Soil Map—Webster County, Missouri

Webster County, Missouri (MO225)			
Map Unit Symbol	Map Unit Name	Acres in AOI	Percent of AOI
70094	Basehor fine sandy loam, 8 to 35 percent slopes, rocky, very stony	31.1	6.3%
73008	Viraton silt loam, 2 to 5 percent slopes	241.9	48.9%
73024	Mano-Ocie complex, 8 to 15 percent slopes, stony	30.6	6.2%
73450	Goss-Wilderness complex, 3 to 8 percent slopes	154.0	31.1%
73555	Hobson loam, 3 to 8 percent slopes	29.6	6.0%
76008	Cedargap gravelly silt loam, 1 to 3 percent slopes, frequently flooded	7.5	1.5%
Totals for Area of Interest		494.7	100.0%

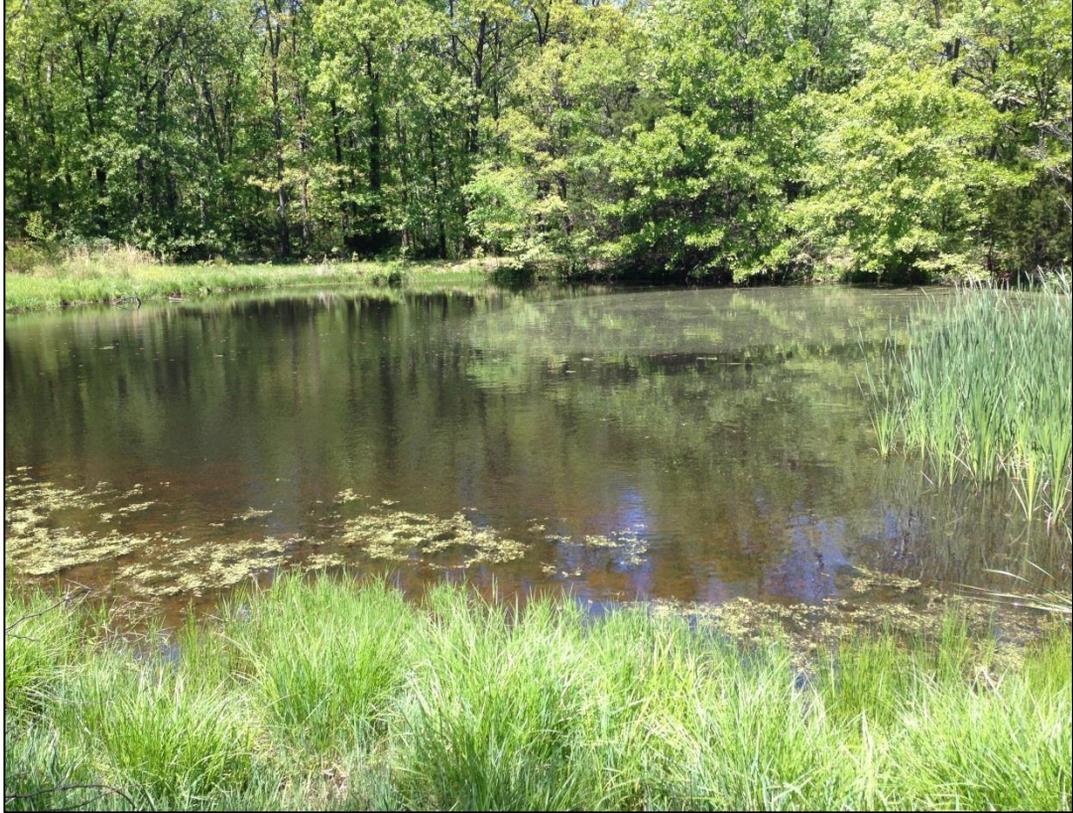
Photograph #1
Taken By: D. Nowack
Date: 5/4/16

View looking west at
the freshwater pond
and wetlands
partially on the
subject property.

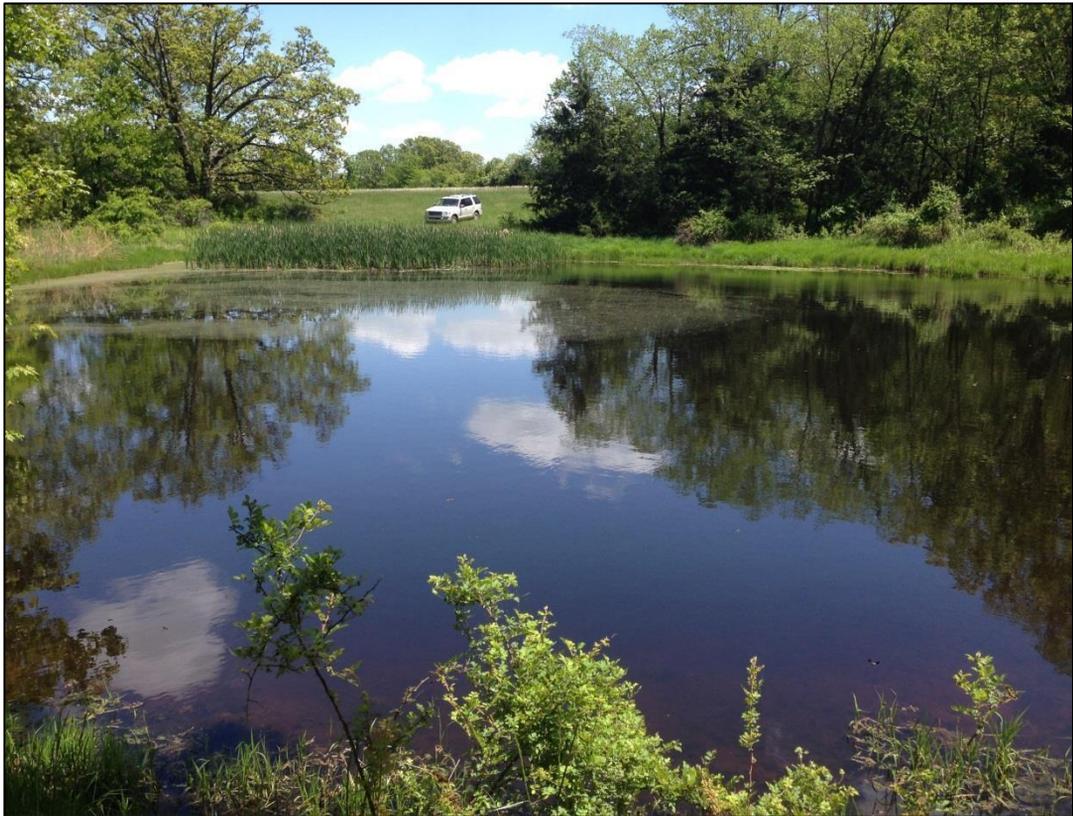
Photograph #2
Taken By: D. Nowack
Date: 5/4/16

View looking east at
the freshwater pond
and wetlands
partially on the
subject property.

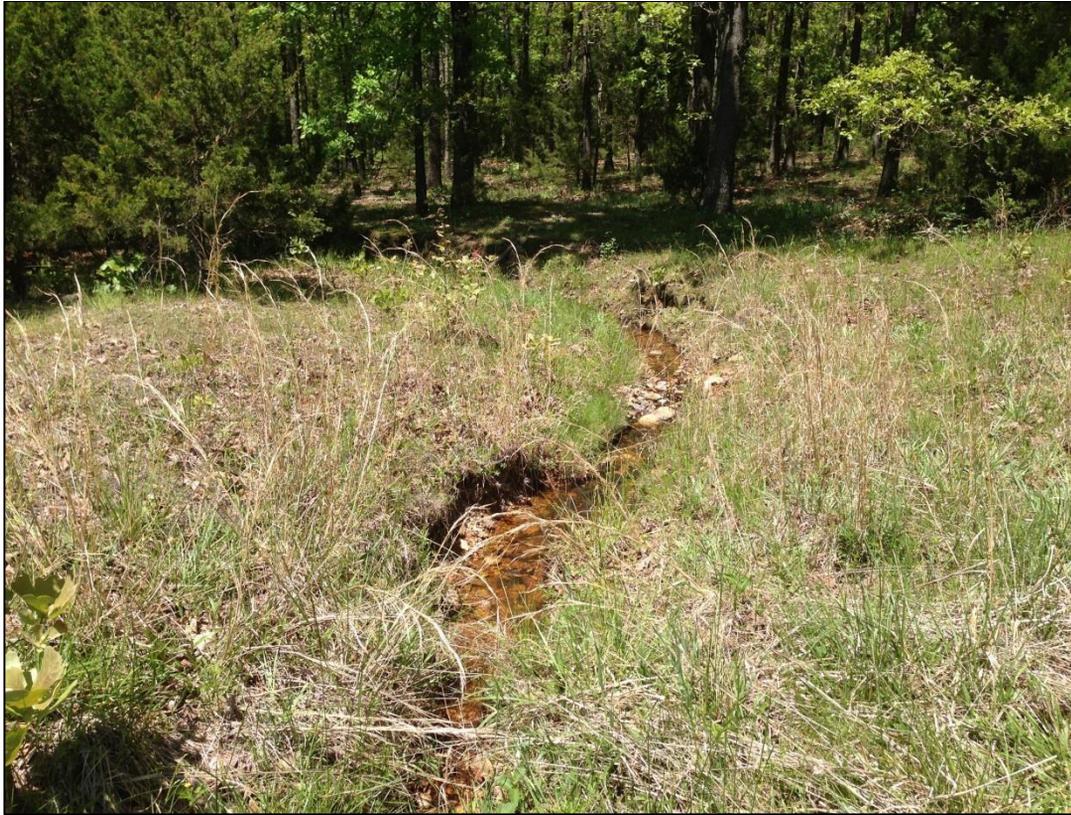
Photograph #3
Taken By: D. Nowack
Date: 5/4/16

View looking north at
the stream
originating from the
freshwater pond
partially on the
subject property.

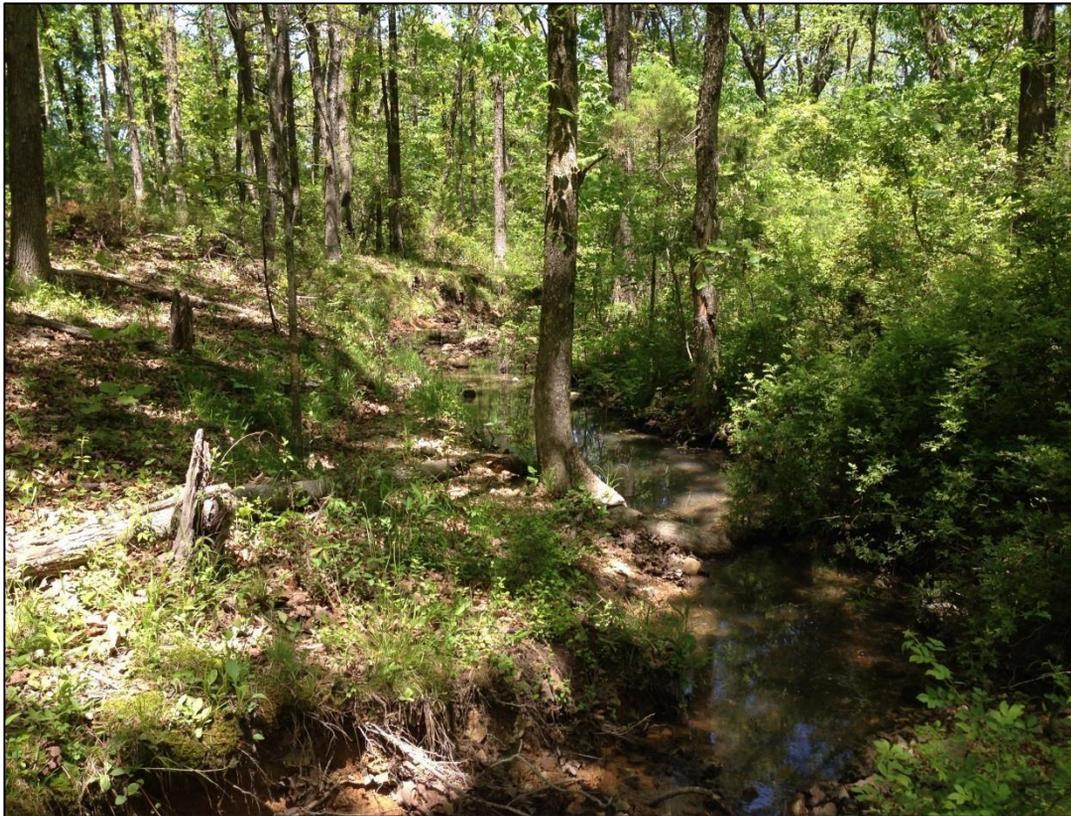
Photograph #4
Taken By: D. Nowack
Date: 5/4/16

Intermittent stream
flowing across the
northwest corner of
the subject property.
